## SIMPLIFIED SAFETY INVESTIGATION REPORT

REPORT NO.: 04/2017

### **MT ASKARA** **Fire in the engine-room** **In position 22° 15' N 115° 01' E** **05 March 2016**

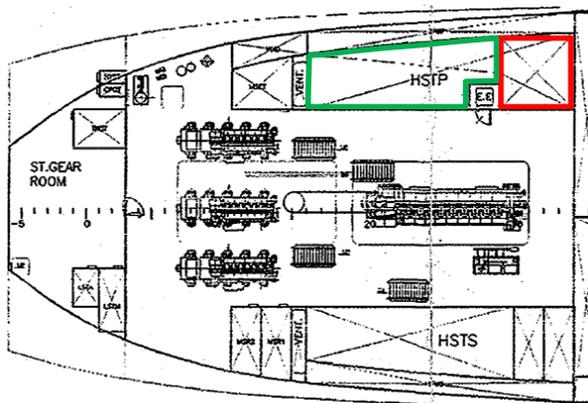
An inspection inside the engine-room soon after it was safe to access, revealed that the low level alarm switch that was dismantled was not actually fitted on port HFO storage tank but on port HFO settling tank. The wrong low level alarm switch had therefore been dismantled. At the time, port HFO settling tank, which was located adjacent to port HFO storage tank (Figure 1), contained about 27 metric tonnes of HFO (380 cSt).

Figure 1: Location of port HFO storage tank (green outline) and HFO settling tank (red outline)

The third engineer was aware of the location of the storage and settling tanks. However, there were no markings on the low level alarm sensors and the wrong alarm was dismantled. It was unclear to the safety investigation as to whether or not the third engineer misunderstood the second engineer's instructions. However, it was concluded that the lack of markings in way

- All bunker system components (including valves, flanges, sensors drains, *etc.*), were identified and marked with a stencil;
- A new bunker tank component checklist has now been included in the safety management system;
- Tool box meetings and risk assessments have been included in Company-run seminars for senior and junior engineers;
- An internal investigation was carried out in accordance with Section 9 of the ISM Code and the findings were distributed on board Company ships<sup>4</sup>.
