SAFETY INVESTIGATION REPORT

REPORT NO.: 15/2017

June 2017

MT GIANNUTRI **Crew member fatality following a fall into an empty cargo oil tank at a shipyard in Riga, Latvia** **21 June 2016**

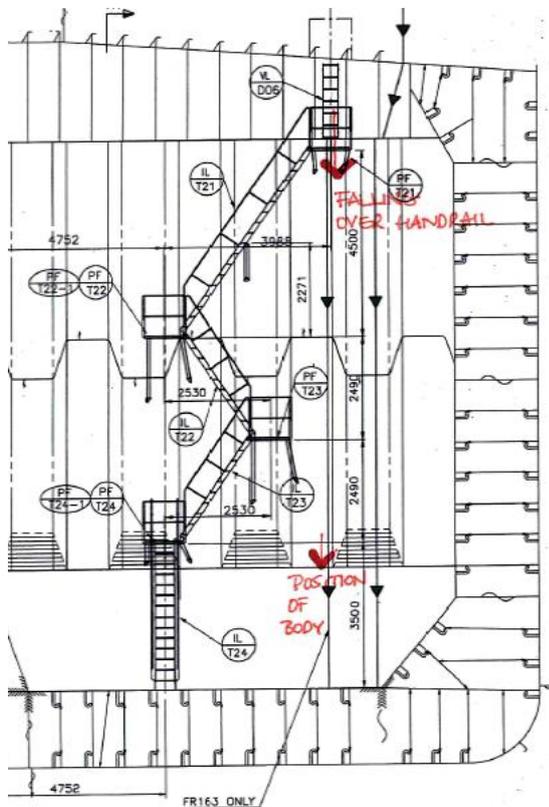
By now, heavy rain was pouring. Rather than making their way to COT no. 2 port, the OS and the 1200 - 1600 AB proceeded to take shelter in the starboard deck store, forward of the manifold. After a few minutes, at approximately 1603, with the rain having subsided slightly, the OS quickly made his way across the deck towards COT no. 2 port and hurriedly disappeared down, behind the tank coaming (Figure 1).

Figure 1: Transverse section and access to the COT

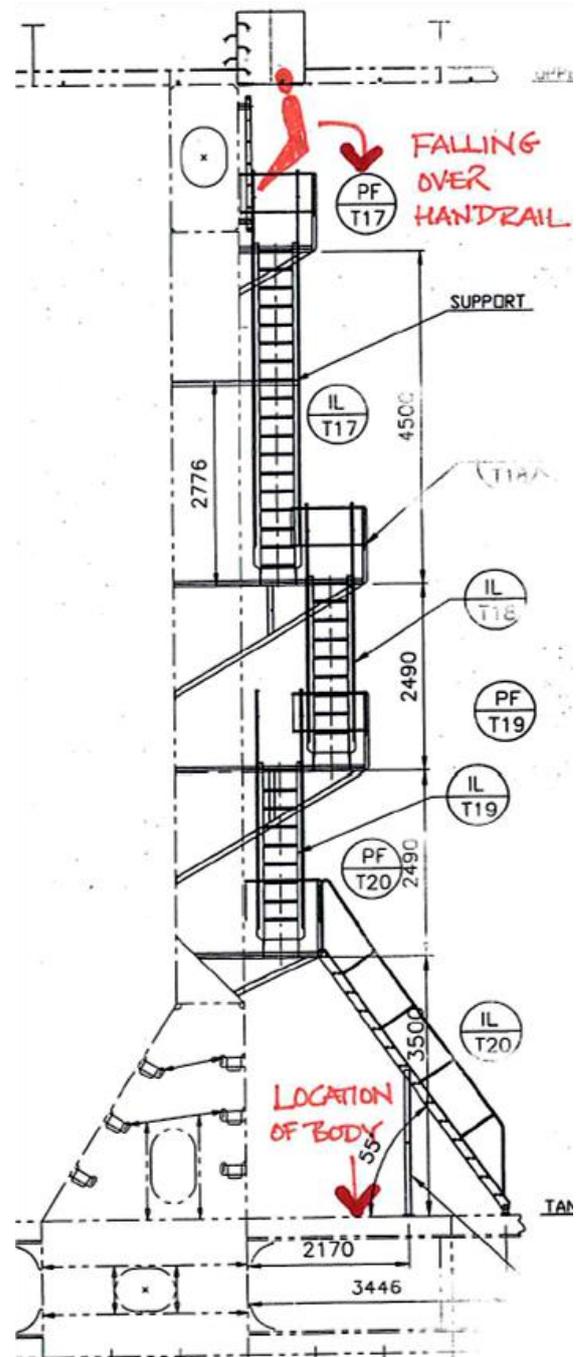
The AB followed the OS just a few moments later. By the time he looked down the coaming, he could just make out what appeared to be the OS falling over the handrail (Figure 2).

Figure 2: Sketch of the accident

Indeed, the OS had fallen from a height of about 14 m, down to the bottom of COT no. 2 port. The AB raised the alarm, and while one of the painters exited the COT

- Toolbox meetings are to be attended by senior ranks and personnel / crew members assigned to carry out the actual work;
- Forecast changes in the conditions which affect risk, need to be addressed during toolbox meetings.

15/2017_R1 carry out regular observations on board as part of their proactive safety management in order to analyse, understand and address how crew members carry out tasks on board.
