SAFETY INVESTIGATION REPORT

REPORT NO.: 07/2017

MV Azamara Quest **Fire in the engine-room** **In position 19° 51.7' N 068° 31.8' E** **27 April 2016**

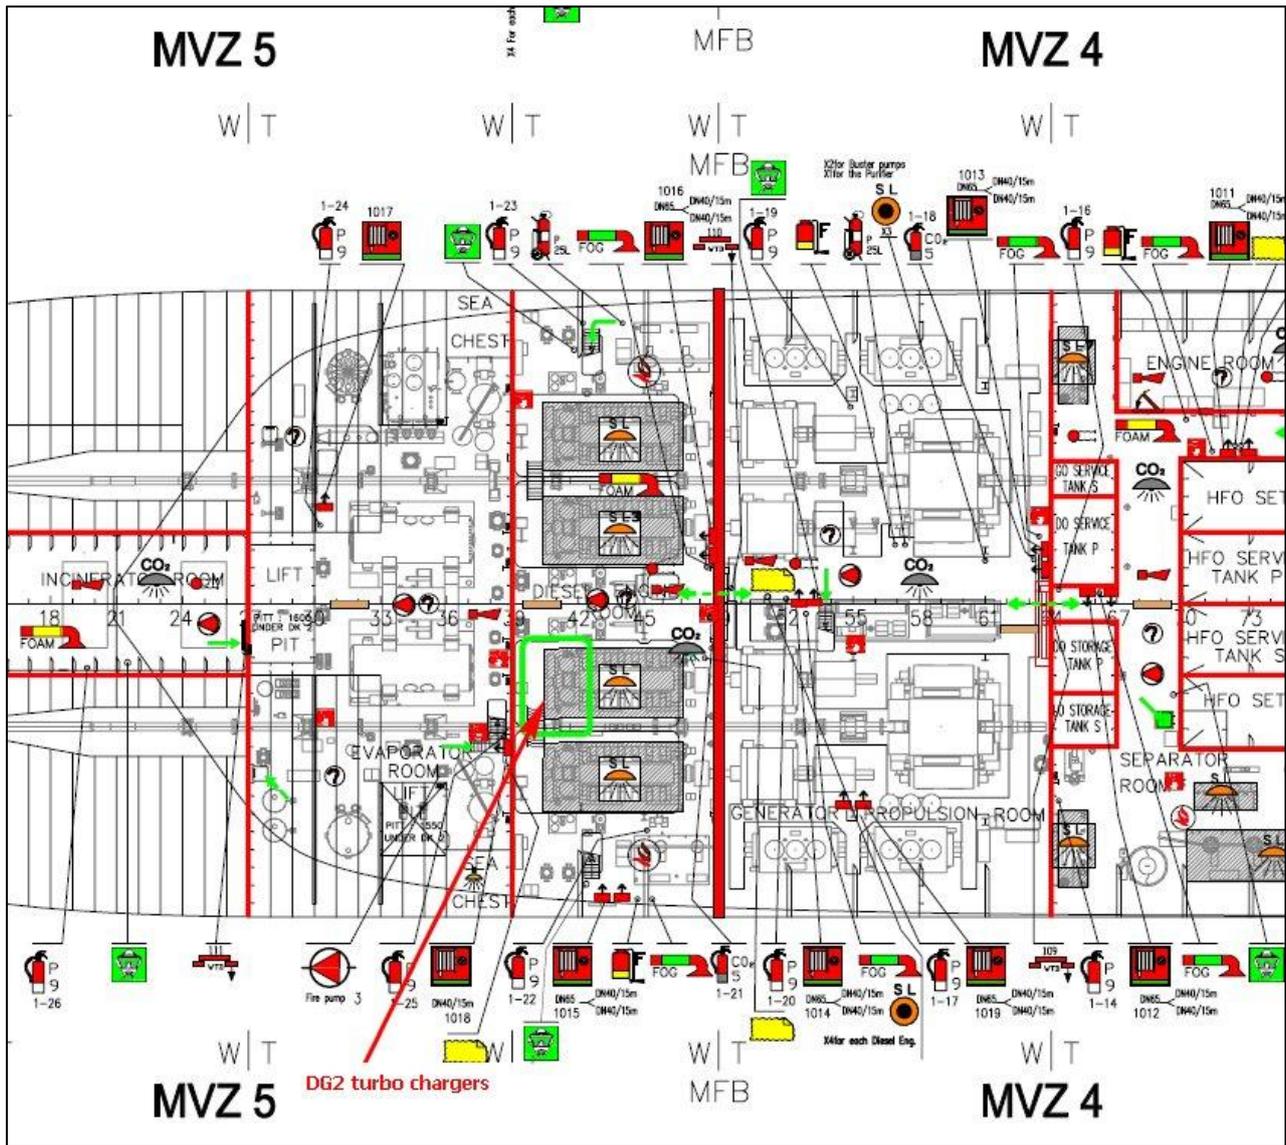
Figure 1: Part of the engine-room's general arrangement plan, showing the location of the fire in way of DG no. 2 turbo charger casing

From the inside, the staff chief engineer saw a dark orange fire below the turbocharger casing on DG no. 2, in way of the prime mover's B-bank (Figure 1). At the time, there was little smoke and he could still see well within the space.

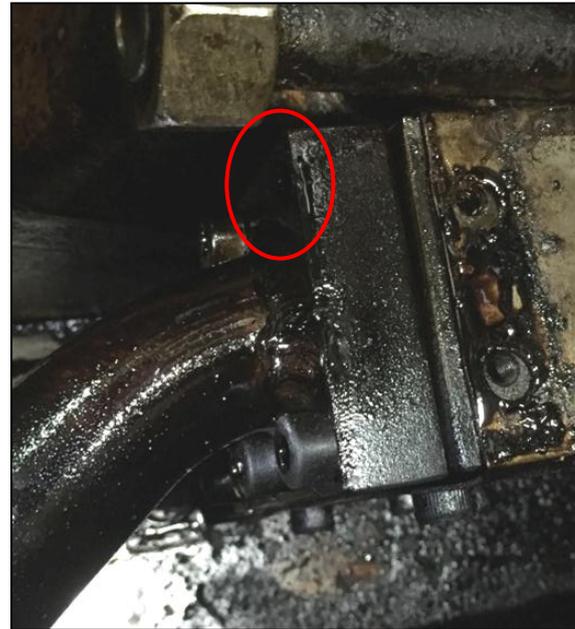
The immediate cause of the fire was found to be a pressurised fuel oil leak on the fuel oil supply line to the high pressure fuel oil pumps. The fuel oil leak was in way of a connecting flange on the A-bank side of the A-B set pipe. The top left Allen bolt was found completely loose and had actually fallen out of place. The remaining three Allen bolts were also loose.

Figure 2: Missing Allen screw

The MSIU did not have access to the Allen bolts and therefore, a metallurgical analysis was not carried to determine whether there was any damage to the threads.

It has to be pointed out, however, that the safety investigation ruled out any potential problems (say, damaged thread) with the missing Allen bolt, given that the three other bolts were also found loose.

The absence of damages to the thread of the Allen bolt may be suggestive that there were no anomalous operations of the pump, which could have caused the loosening of the bolts. While the safety investigation noted that the maintenance history in Figure 3 showed that the bolts had been tightened to the torque recommended by the manufacturer (23 Nm)³, it was not excluded that actually a lower torque may have been

applied, thus allowing for vibration to loosen the bolts.

Taking into consideration that the prime mover had only been working for a total of 39 hours from the time it was maintained until the fire, it was considered possible that actually vibration was a major contributing factor to the loosening of the four Allen bolts, fitted in somewhat awkward positions.

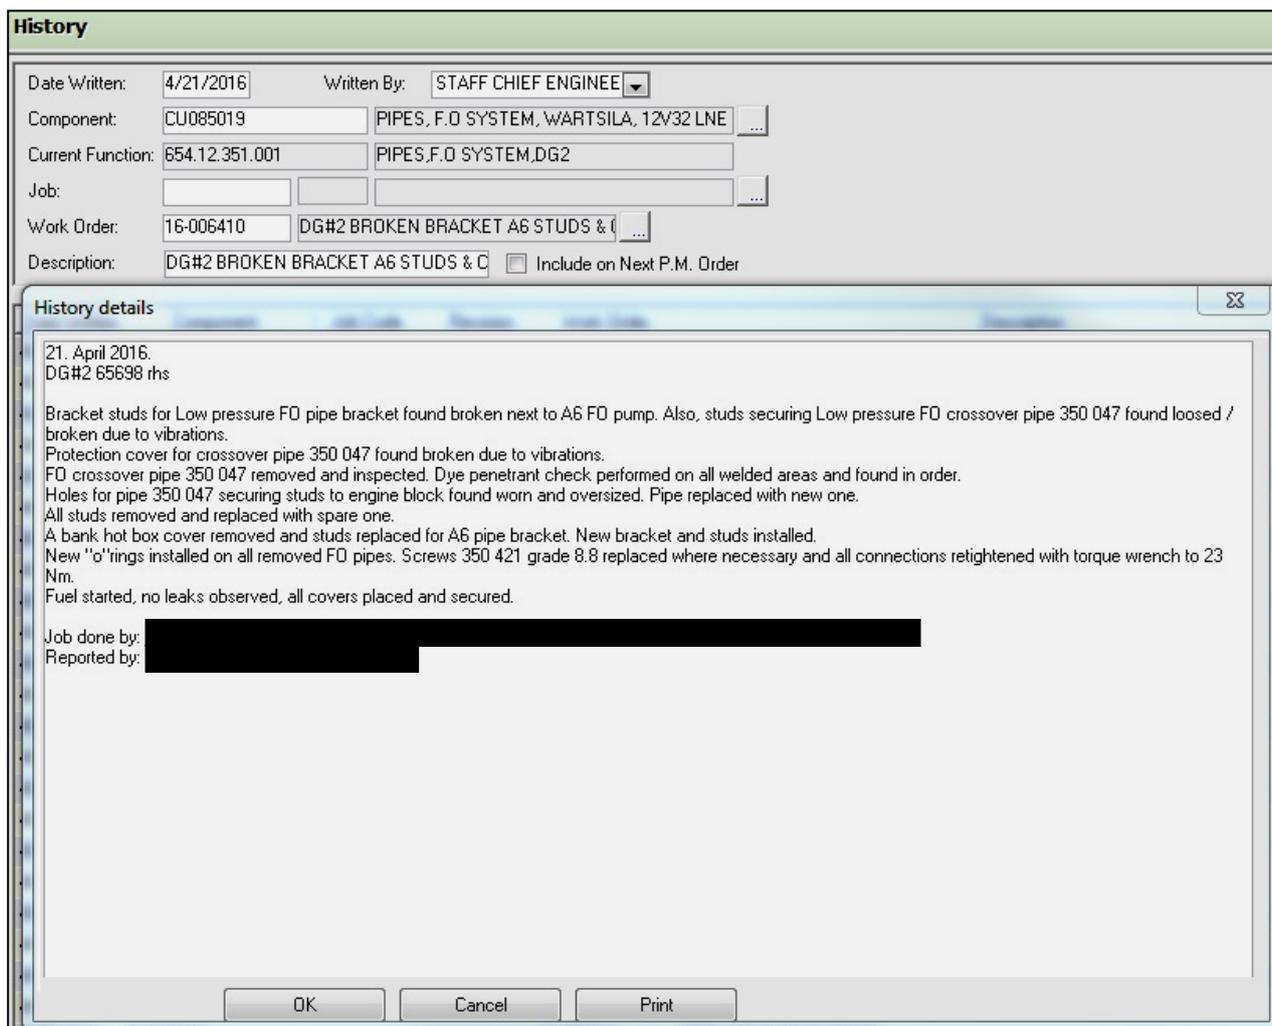
Engine-room records collected during the course of the safety investigation indicated that the last maintenance on the pipe was carried out on 21 April 2016 (Figure 3).

Figure 3: AMOS history report (screen dump)

The task was actually ‘breakdown’ maintenance after the engineers noticed a broken pipe bracket and a loose bolt on the bracket.

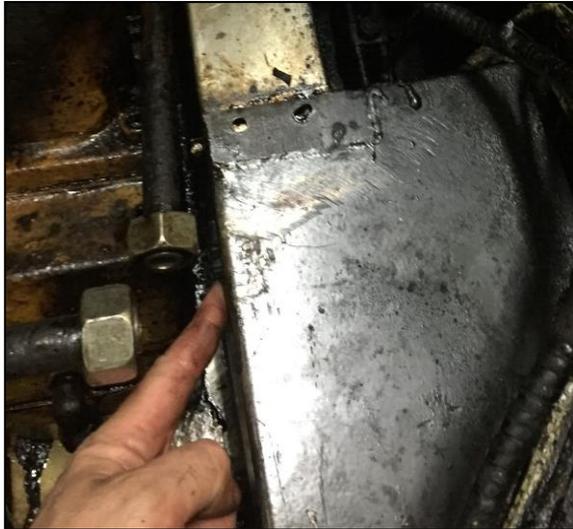
It has been confirmed that the prime mover had always been fitted with protection covers to prevent leaking fuel oil from reaching hot surfaces (Figure 4). Despite this, a closer inspection revealed that fuel oil

had sprayed at a pressure of 8 bar, underneath the protective cover, penetrated through the gaps in the exhaust lagging screen, reached the exhaust pipe and auto ignited.

Figure 4: Protection covers in way of the fuel oil lines

It would appear that these gaps had never been detected during the regular maintenance on the DG; however, it has to be stated that this would have been a difficult task, if not an impossible one, given the narrow and small spaces involved.

Although the covers had been installed as per maker's design, the Company fitted SOLAS splash tape on the affected flange and pipe as an added protection barrier system (Figure 6).

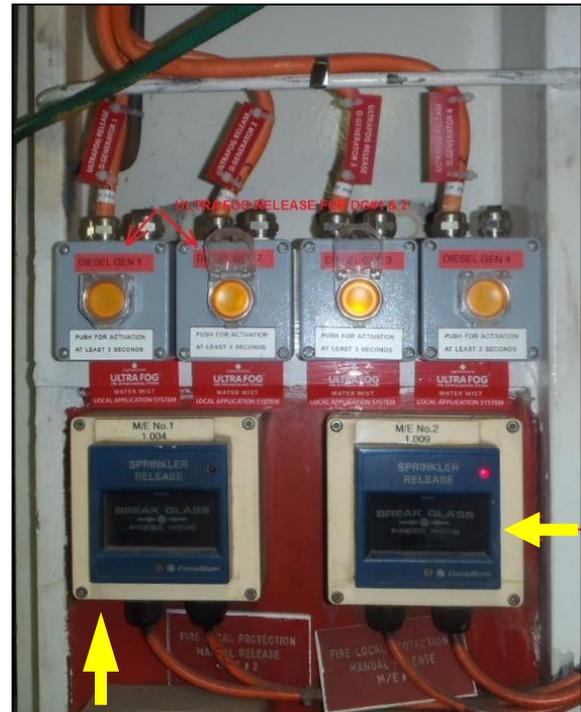
It would appear that the staff chief engineer tried to activate the water mist system by pressing the (blue) release buttons (Figure 5). It has been clarified, however, that the (blue) water mist release system buttons had been integrated in the new ultra fog system as manual call points during the vessel's latest dry docking earlier during the month of April.

Figure 5: Blue buttons below the ultra fog system

Moreover, the Company replaced the (blue) release buttons on the water mist system with red call buttons to avoid any confusion (Figure 8). The Company has also addressed this issue through its crew familiarisation procedure.

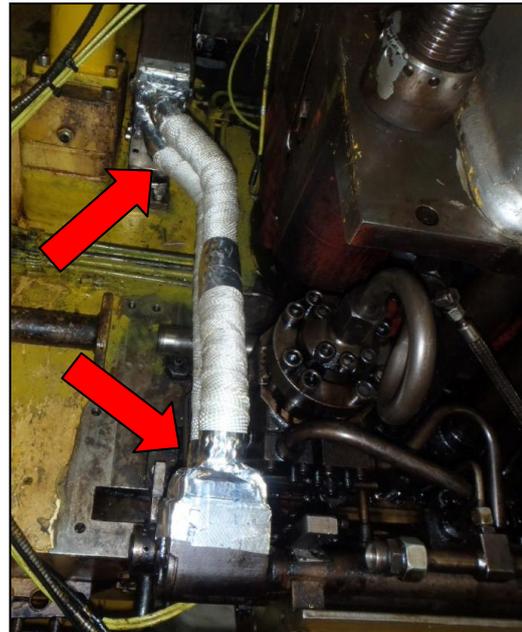
Figure 7: Splash tape fitted after the fire

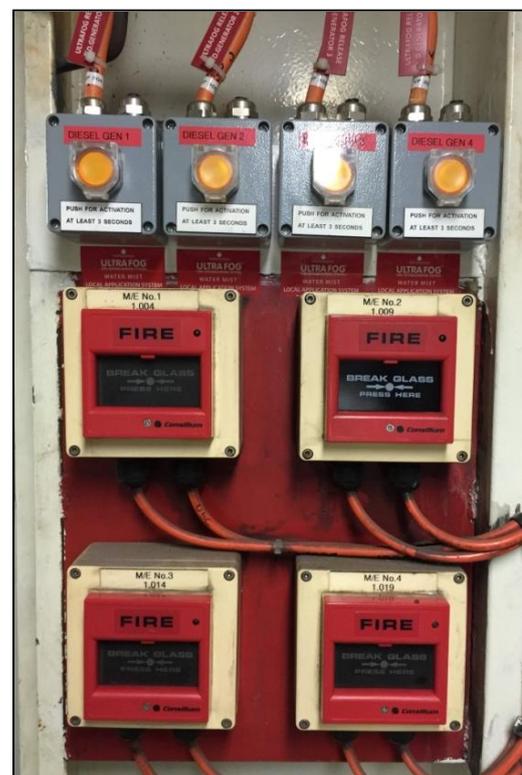
Figure 8: New call points in red casings
