SIMPLIFIED SAFETY INVESTIGATION REPORT

REPORT NO.: 05/2017

MV CIELO DI TOCOPILLA **Serious injury during mooring operations** **In the Port of Ilo, Peru** **27 March 2016**

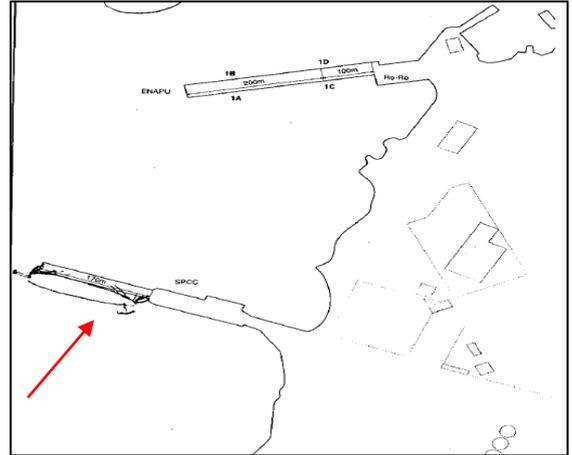
Figure 2: Sketch showing *Cielo di Tocopilla* on the South breakwater pier

Cielo di Tocopilla was moored port side on the South pier of the port's South breakwater with starboard anchor and stern lines fast to a conventional mooring buoy (Figure 2). Additionally, she had four headlines, three backspring forward and four backspring aft secured on the pier.

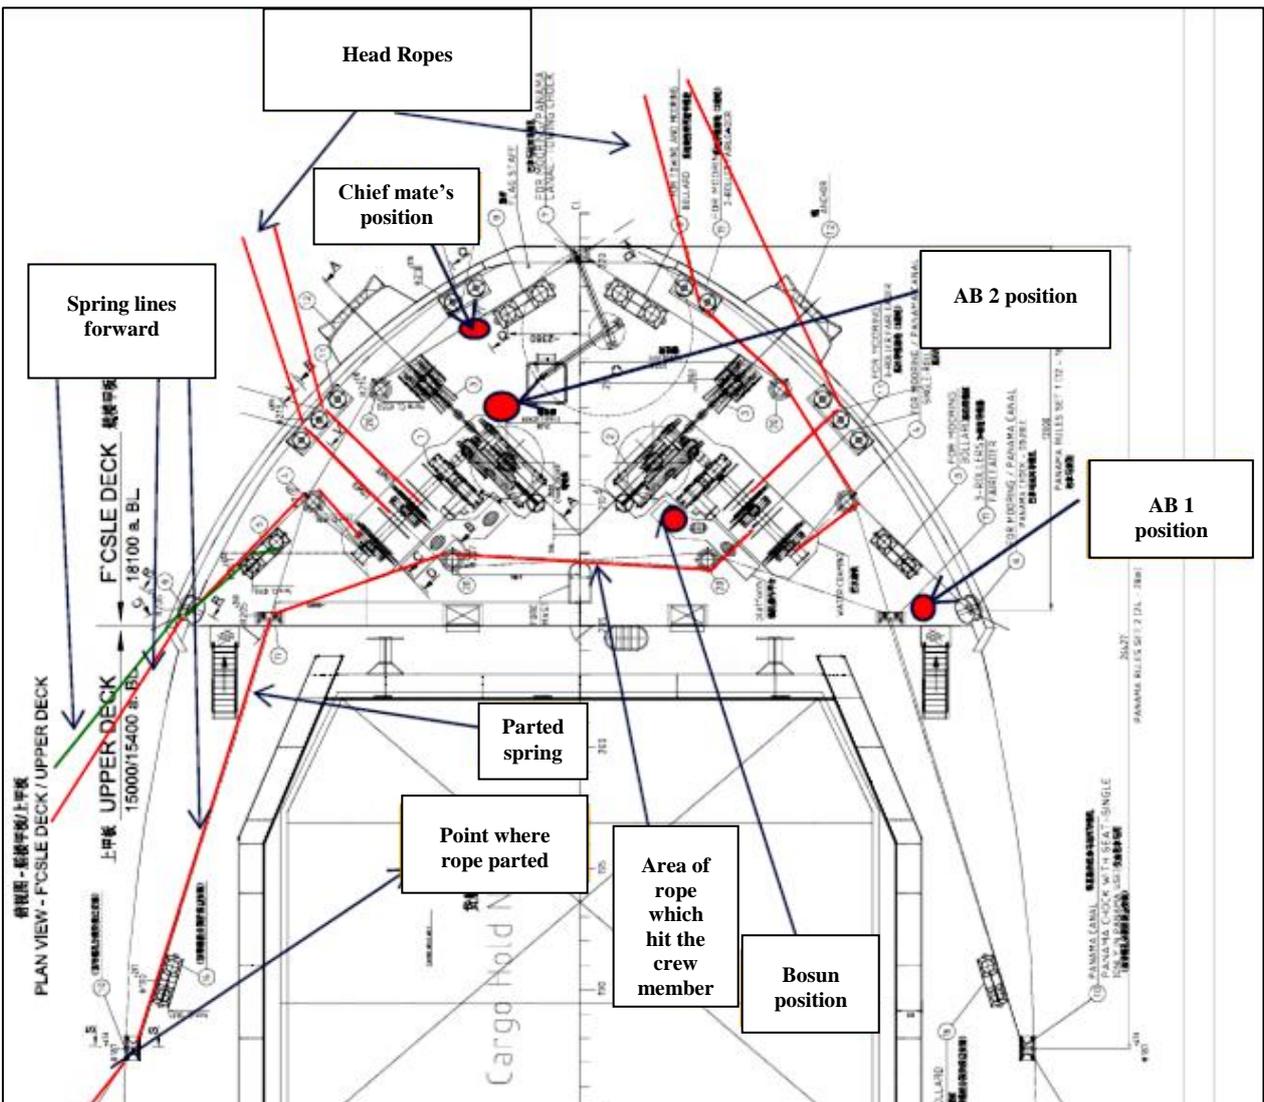
Figure 3: Arrangement of mooring lines and position of mooring crew on forecandle deck

The remaining backspring was led from the starboard winch through a series of pedestal rollers abaft of the winch to the port shoulder fairlead, abreast of cargo hold no. 1. From there, about 60 m of the line was run to the shore bollard. The chief mate standing near the vessel's stem had an outward view of the mooring lines. The bosun was operating the starboard windlass/winch (Figure 3 and 4).

The port of Ilo had developed a mooring layout not normally found in sheltered ports. *Cielo di Tocopilla* was berthed with a number of head ropes and backspring, starboard anchor and stern lines. The need for such mooring arrangement had formed an unfamiliar mooring pattern on the forecastle deck. One of the backspring (and the last one to cast off) was led from the starboard mooring drum to the port shoulder fairlead on main deck (Figure 3).

In between, the line was led through a number of pedestal rollers and fairleads.

Each lead had thus created a new direction and snap-back hazard, which had no relevance to the snap-back zones painted on deck. As the outboard section of the backspring came under high dynamic load, it stretched and parted. The recoil from the sudden release of energy was transmitted through the onboard section of the rope. The energy, albeit somewhat weakened, was powerful enough to whip up the penultimate section of the backspring across the working platform.

In this instance, the marked snap-back zones afforded no security to the bosun operating the winch. This was so because the lead and direction of the backspring had introduced divergent snap-back hazard, which could neither be documented nor addressed in the tool-box meeting with the crew.

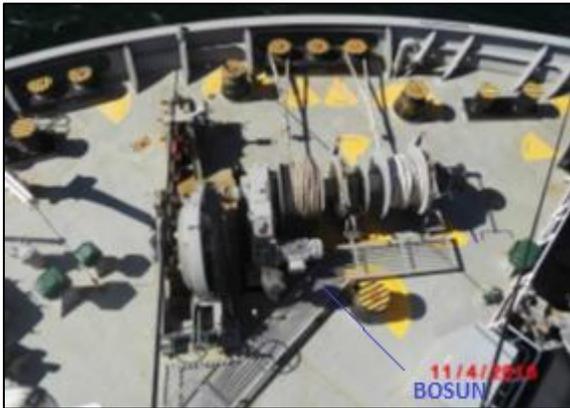
Figure 4: Starboard mooring windlass/winch showing approximate position of the bosun

During the un-berthing operation, *Cielo di Tocopilla* ranged up and down the breakwater. The chief mate thus directed the bosun to adjust the tension on the backspring. The main engine was also momentarily put astern to arrest her forward motion. However, at about 2224, *Cielo di Tocopilla* was pounded by heavy swell causing her to surge and heave. The sudden load brought on by the wave caused the backspring to part. The whiplash of the mooring rope section remaining on board struck the bosun on his right leg.

The forecastle deck on *Cielo di Tocopilla* was fitted with port and starboard windlass/winches with a design load of 672.5 kN. Each windlass/winch had storage, tension and warping drum. Abaft the winches, a platform approximately 20 cm above the deck was mounted to give the winch operator a clear view. A number of bitts, pedestal rollers and fairleads were mounted to give a range of mooring configurations. Snap-back zones had been painted yellow (Figure 4) and information about them was available in the ship's safety management system.

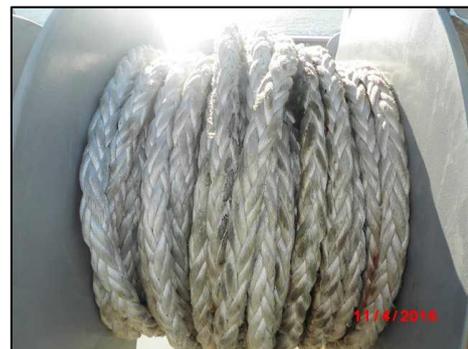
Figure 5: Photo of on-board section of the backspring on storage drum

The two year old mooring rope, which was constructed of 40% polyester and 60% polypropylene, had 24 strands (Figure 5). The inner and outer strands were intact and had neither any abrasion marks nor kinks. The rope had a certified minimum breaking load of 496 kN.

The mooring rope had severed at the port shoulder fairlead when it came under load from the surge wave.

The Company has also required that extraordinary safety meetings are held on board prior to every visit to exposed ports, mooring ropes are adequate and suitable for the intended purposes, which encompasses also their inspection, maintenance and eventual replacement.
