## SAFETY INVESTIGATION REPORT

REPORT NO.: 10/2017

### *MV Delfini*

### **Burn injuries to two persons at Sliema Ferries, Sliema 20 May 2016**

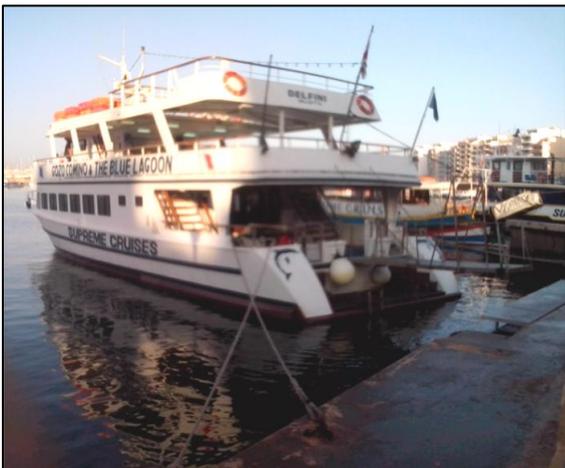
Figure 1: *Delfini* moored stern-to

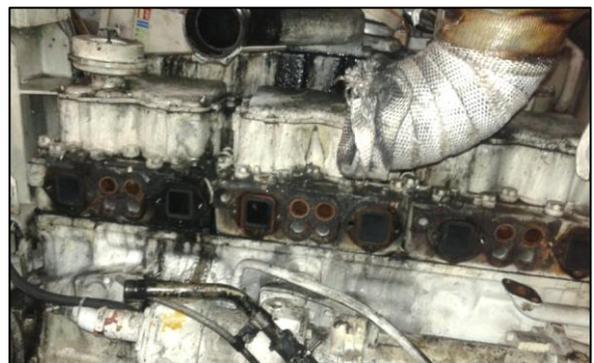
**Figure 3: Dismantled exhaust manifold, turbocharger and exposed exhaust ports**

As with regards to the accident, the MSIU was of the opinion that when the engine was stopped for the night, the faulty fuel injector/s may have leaked minute droplets of fuel onto the piston crown. When the engine was started the following morning (with the exhaust manifold and turbocharger removed), the (accumulated) fuel late ignition escaped through the exhaust ports producing an after-burning flame that injured the two shore-based maintenance personnel.

The practice of removing the exhaust manifold and turbocharger and start the engine is dangerous and not a recommended maintenance practice. Notwithstanding, the no alternative measures were adopted.

***10/2017\_R1*** a planned maintenance regime on all Company operated vessels, in accordance with recommended maintenance schedules.

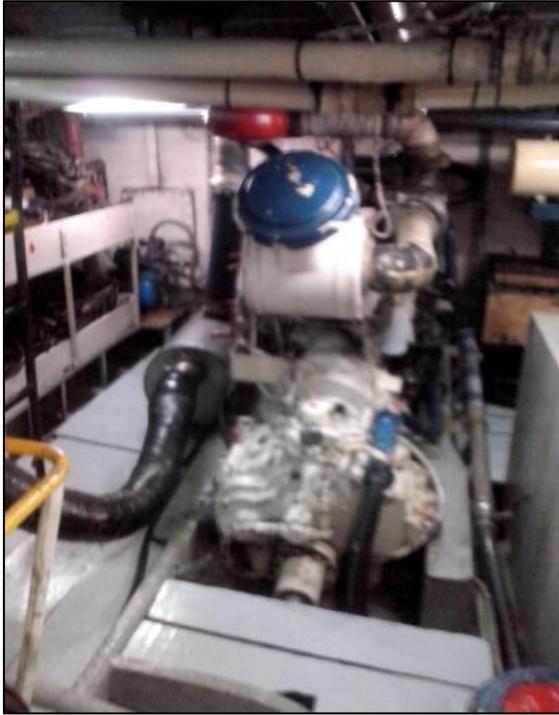
Accessibility around the engine-room was very restricted (Figure 4) and it was therefore necessary for the two mechanics to stay very close to the port main engine during the starting operation.

**Figure 4: Restricted accessibility around the port main engine**
