SAFETY INVESTIGATION REPORT

REPORT NO.: 14/2017

MV *HS ROSSINI* **Fatal fall during bunker operations** **in the port of Durban, South Africa** **19 June 2016**

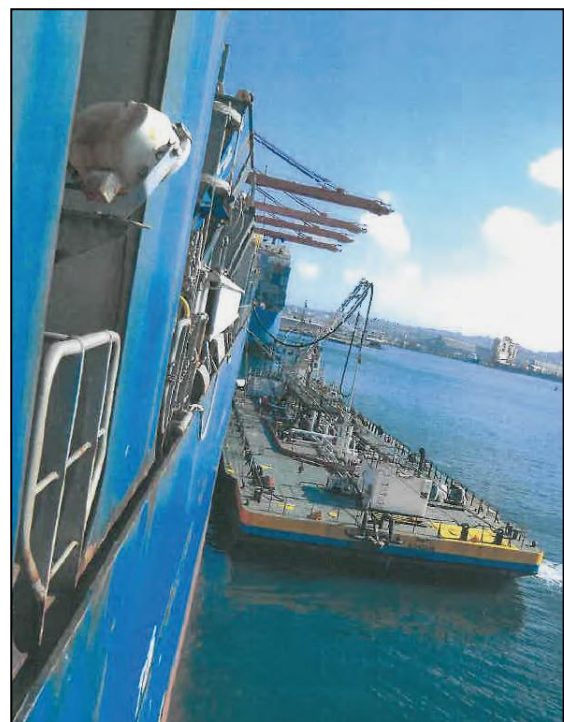
Figure 1: Bunker supply barge *Smit Bongani* alongside *HS Rossini*

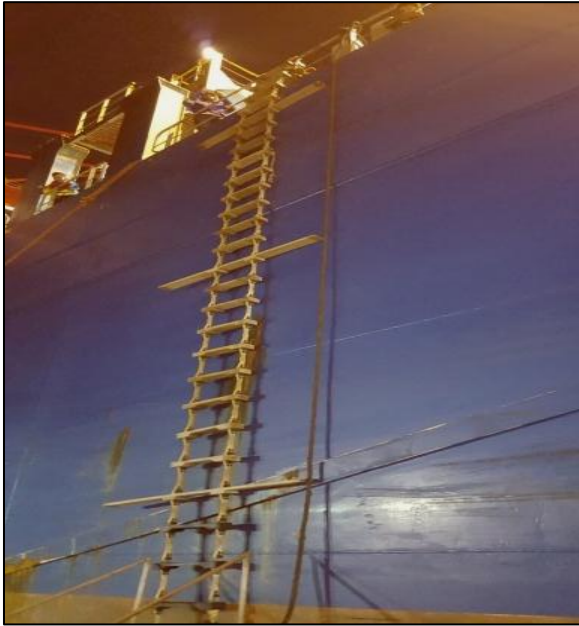
A pilot ladder was secured over the ship's starboard rail, abreast of cargo bay 13. The vertical distance of the ladder from the main deck to the bunker supply barge deck was about 9.5 m (Figure 2). Artificial light from the vessel and the bunker barge illuminated the pilot ladder. Meanwhile, bunker stations were called on *HS Rossini*. The second engineer filled in the bunker checklist while

Figure 2: The pilot ladder, down to the bunker supply barge

There was no evidence of abrupt vessel movements at the time of the accident, or that the ladder was improperly rigged / slippery rungs. A crew member on *Smit Bongani* did witness the fall and reported that the third engineer was straining as he climbed up the ladder. Half way up, he momentarily paused, lost his hold on the ladder and fell down.

14/2017_R2 in the use of a safety harness when using the pilot ladder.
