MARINE SAFETY INVESTIGATION REPORT

Safety investigation into a crew member fatality on the
Maltese registered bulk carrier

PERTH I

MARINE SAFETY INVESTIGATION REPORT NO. 11/2017

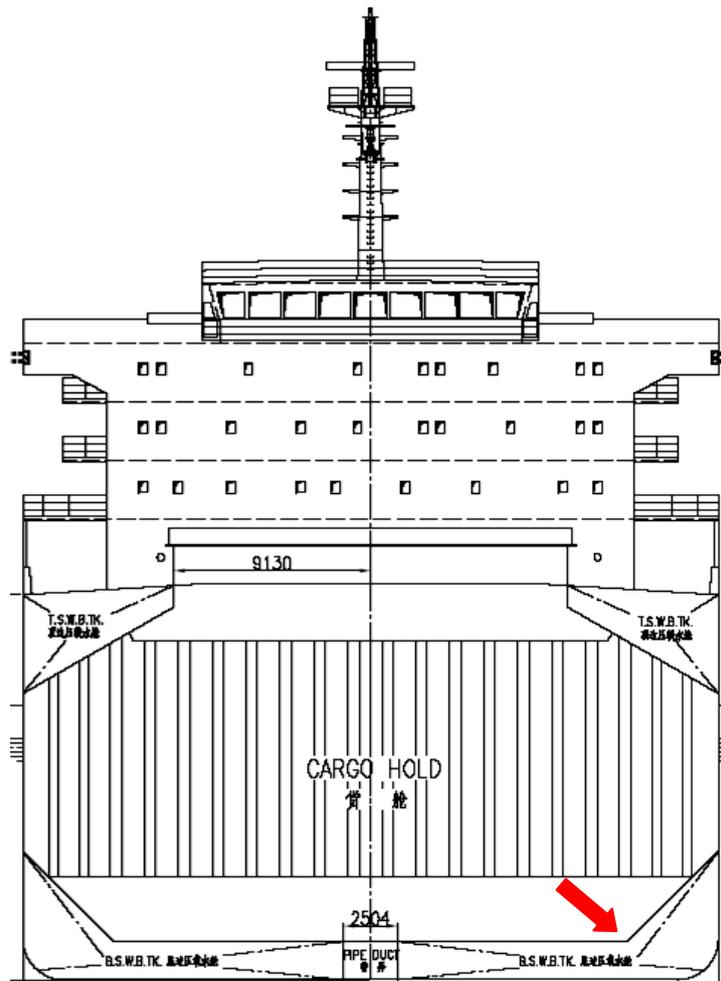
AB 2 reported that he was sweeping the cargo residue which was being dislodged from behind the ballast line and falling down on the tank top. AB 2 recalled that he was placing the residue inside a bag, when at approximately 1845, he heard a loud noise; he turned around and looked upwards. At that moment, he witnessed AB 1 rolling down the hopper tank (Figure 2) and coming to rest on the tank top below.

Figure 2: General arrangement of the cargo hold no. 1, showing the accident site

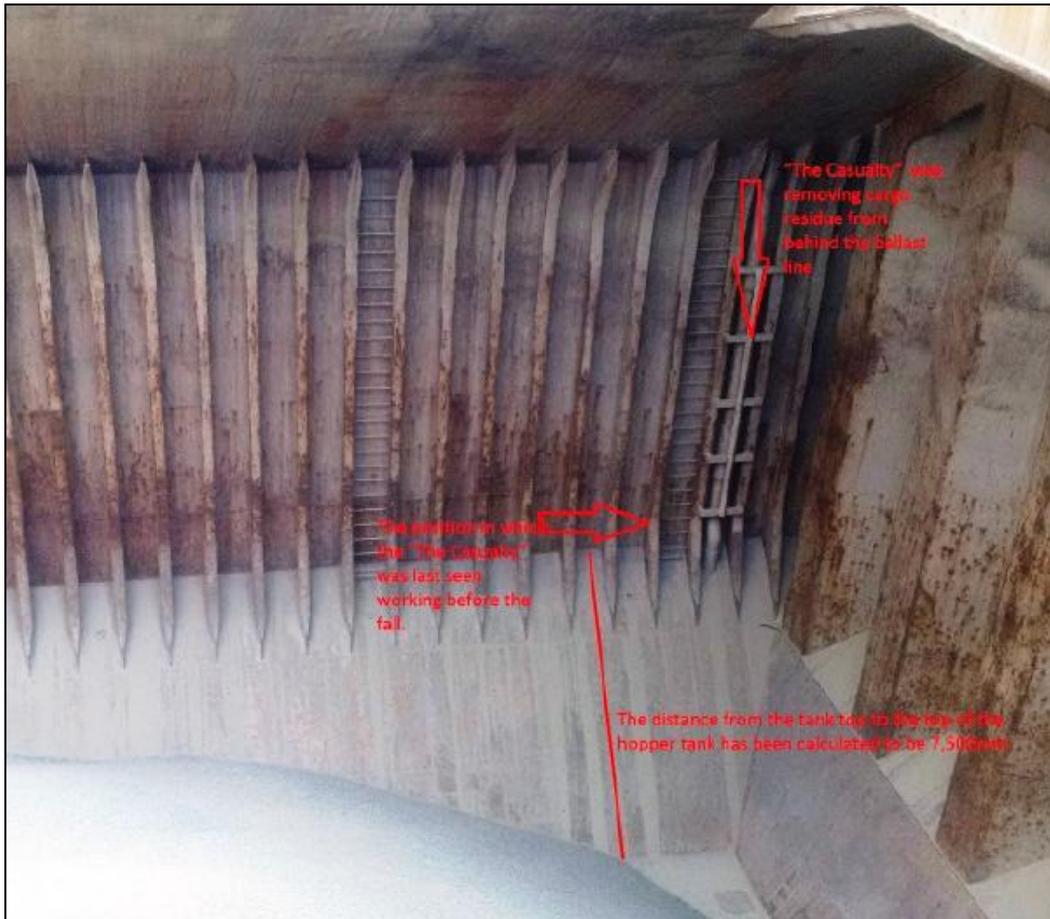
It was reported that at the time of the occurrence, AB 1 was standing on the lower rung of the vertical fixed side ladder in way of side shell frames 214 and 215 (Figure 3). The calculations suggested that he had been working at a height of between 8,000 mm and 9,500 mm above the tank top of cargo hold no. 1 on the port side. Both the master and the chief mate stated that the aluminium ladder was positioned flat against the hopper tank (Figure 4) and that no other equipment and obstructions were present in the cargo hold at the time of the accident.

The aluminium ladder used by AB 1 to access to the top of the hopper tank had a length of 6,000 mm and the distance between the top of the aluminium ladder and the lower rung of the fixed steel ladder had been calculated to be 1,500 mm.

Figure 3: Position of the AB when he was cleaning cargo residues behind the ballast line

Although the safety investigation is of the opinion that the AB must have unclipped his safety harness and lost his footing while transitioning between the two ladders⁸, the MSIU did not exclude the possibility that AB 1 lost his footing due to the vessel's movement. It was reported that the vessel was rolling and pitching gently. Although the conditions were neither rough nor considered to have posed a significant risk to the crew members inside the cargo hold, the weather may have been a contributing factor, had the vessel pitched at the same time that AB 1 unclipped his safety harness.

- In accordance with Section 9 of the ISM Code, an internal investigation was carried out and the findings of the investigation were shared with the MSIU and the crew members serving on board Company ships;
- All masters and chief mates are required to attend courses in medical care and first aid, risk assessment, and incident and accident investigation and analysis;
- The relevant sections of the safety management manual have been amended to include information on the cleaning of cargo holds and related safety precautions;
- Additional contact details have been added to the Company's official list to be used in cases of emergency on board.

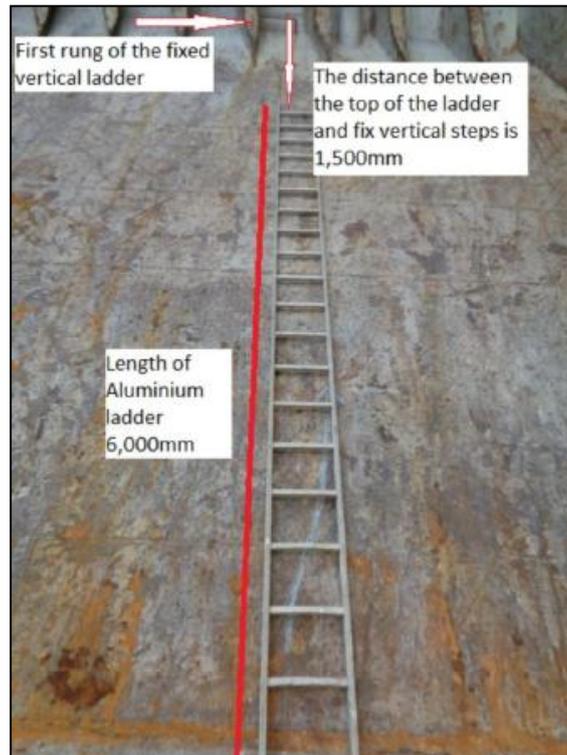
Figure 4: Aluminium ladder positioned flat on the hopper tank

AB 2 stated that he had his back to AB 1 when the latter fell and therefore he was unable to state the exact location from which AB 1 had lost his balance. AB 2 did state, however, that he assumed that his colleague was descending the fixed steel ladder as the work was nearing completion and consequently, he had unclipped his safety harness. AB 1's medical report stated that he was 1,600 mm tall. The distance between the two ladders has been calculated as 1,500 mm. Consequently, AB 1 would have had to hold one of the lower rungs of the fixed vertical steps and then fully extend his body for his feet to reach the first step of the aluminium ladder when descending.
