SAFETY INVESTIGATION REPORT

REPORT NO.: 08/2017

MV SEAGULL **Fatal fall overboard** **in Trincomalee, Sri Lanka** **28 April 2016**

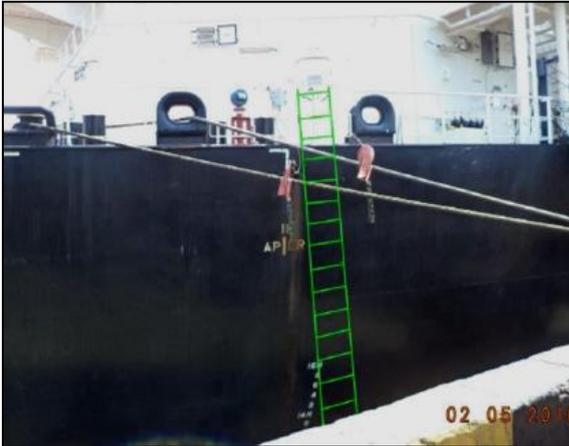
Figure 3: A reconstruction to show how the aluminium ladder had been rigged

this effect, a rigid aluminium ladder was rigged on the starboard side poop deck over the draught marks (Figure 3). At 1730, the chief mate, accompanied by a deck boy, walked to the poop deck and climbed down the ladder to read the aft draught marks. On his way up, however, he briefly stopped; his hold on the ladder eased, and fell in the sea.

with drowning, there was no information on what has led to the fall from the ladder². Thus, on the basis of the deck boy's observations, the safety investigation did not rule out *ischemia* (restriction of blood supply to heart) and momentary loss of consciousness. The subsequent trauma caused by the sudden immersion (albeit in relatively warm water) and the strenuous effort to reach the lifebuoy, may have gravely debilitated the chief mate's physical strength and cardiac function.

While *Seagull's* SMS described safety measures for working aloft / over side, it provided no detailed reference / guidance to the crew. It was not known if the chief mate was aware of these safety measures; it was certain, however, that he followed established work procedures of taking draught readings with only a crew member standing by on deck with a lifebuoy (and possibly no means of communication with the rest of the crew members).

Whilst *per se* this was not considered to be a problem, the main safety issue was the fact that the improvisation by the chief mate was carried out without a clear mental model of the risks involved, but with the intention to complete a step as part of the bunkering procedure.

08/2017_R1 ensure that where fitted, the draught gauges are operational in order to minimise the exposure of crew members to the risk of working aloft.
