SIMPLIFIED SAFETY INVESTIGATION REPORT

REPORT NO.: 06/2017

MV Skysea Golden Era Serious injury to a crew member In the port of Baoshan, Shanghai, China 10 April 2016

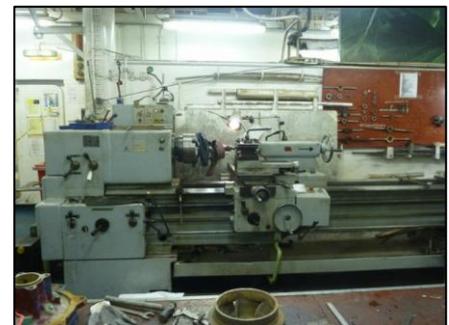
The lathe (Figure 1) was located in the engine-room's workshop, on starboard side, aft of the main engine.

Figure 1: The lathe inside the workshop

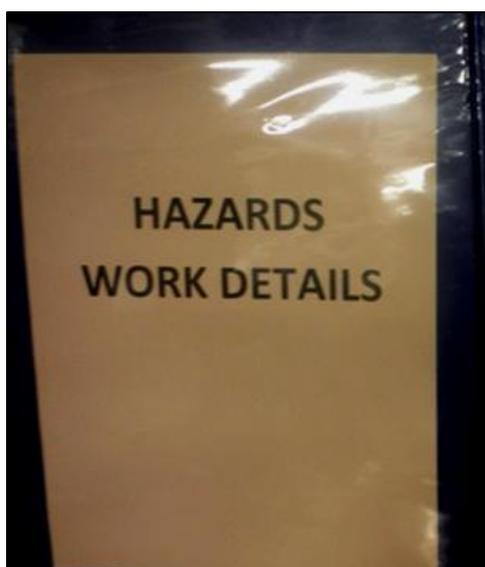
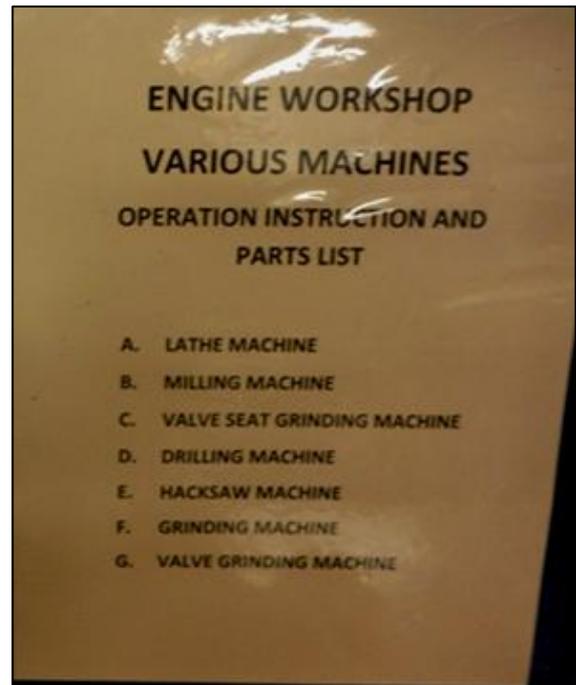
A 'Hazards Work Details' document displayed in the engine workshop (Figures 2a and 2b), listed a number of precautions which the operator had to observe when using the lathe. Notably, it directed the operator to use the chuck guard and not to hold any (rotating) work with the hands.

Figures 2a and 2b: Instructions and work details

The chief engineer reported that the area around the lathe was clean, free of loose material and the platform surface was non-slippery. The artificial lighting was bright enough and the lathe was well maintained and kept in good condition. The safety precautions outlined in the 'Hazards Work Detail' document were observed except for the chuck guard which had never been fitted on the lathe.

During the course of the safety investigation, the Company has placed an order to fit a safety guard on the lathe's chuck. Moreover, the operating procedures were amended and the lathe operation and work practices are now included as part of the on board periodical internal safety audit.

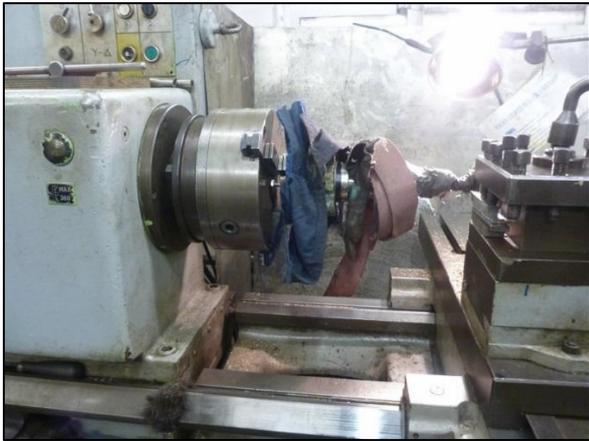
Although no engine ratings witnessed the accident, it was probable that either the emery cloth and/or the loose sleeve of the mechanic's overalls were caught in the rotating chuck. The mechanic was then pulled over and held down over the rotating chuck, outside the reach of the emergency stop button (Figures 3a and 3b).

In addition to the lack of a physical barrier around the chuck, the lathe had another

design problem with the position of the emergency button, which was not within reach of the (trapped and injured) operator.

Figure 3a: Rotating chuck showing overall sleeve & emery cloth entangled on the spindle

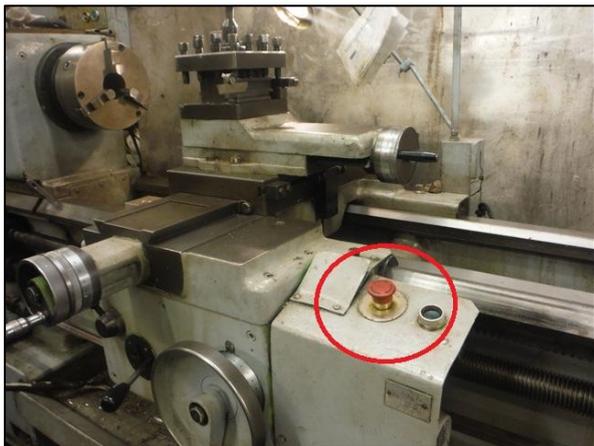
Figure 3b: Emergency stop button on the lathe

06/2017_R1 consider fitting an emergency stop button or pedal in a position that can be reached by lathe operators from all positions.
