## SIMPLIFIED SAFETY INVESTIGATION REPORT

REPORT NO.: 03/2017

## MV VOLA 1

### Serious injury to crew member while letting go the towline In the port of Vlothaven, The Netherlands 05 February 2016

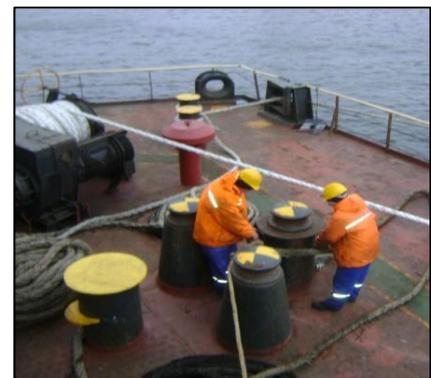
Figure 2: View of aft mooring deck showing simulated position of second mate and the AB 2

The tug's towline was slack. The messenger line attached to it was warped around the winch drum and held by AB 1. The second mate and AB 2 lifted the eye by hand (Figure 2).

Before the eye was set free from the bitt, the towline became taut. The pull on the towline was unforeseen and sudden. The left hand of AB 2 was drawn with the towline and trapped against the bitt. At the time of the accident, the fitter was on the winch control panel and the motorman was handling the stern line (Figure 3).
