SAFETY INVESTIGATION REPORT

REPORT NO.: 17/2012

September 2012

MT TRANS SCANDIC **Loss of Pygas cargo** **Whilst on passage** **Between 29 and 30 December 2011**

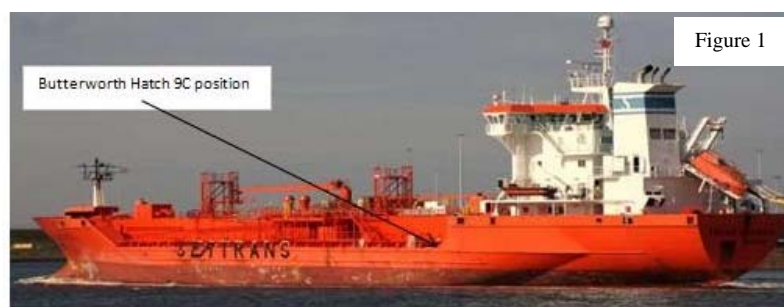
Figure 1

Trans Scandic (Figure 1), a Maltese registered oil and chemical tanker, lost approximately 125 mt of Pyrolysis Gasoline (Pygas) from the Butterworth opening of the no. 9 centre cargo tank.

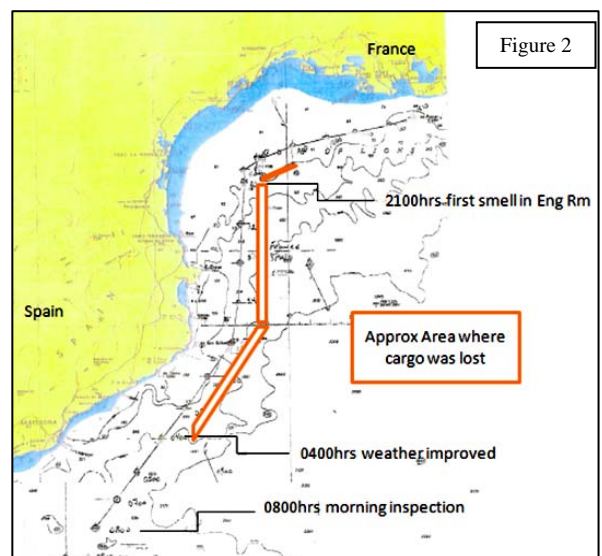
The course was set at a distance of no less than 12 nautical miles from the coast (Figure 2)². It was forecasted that rough weather would be approximately 45° to the aft starboard quarter.
