# SIMPLIFIED SAFETY INVESTIGATION REPORT

REPORT NO.: 19/2016

## MV SOVEREIGN Serious injury to crew member during mooring operation 08 October 2015

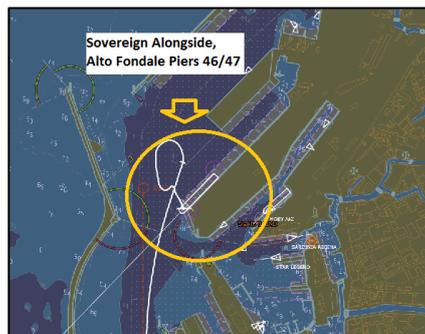
Figure 1: Alto Fondale Pier 46/47, Livorno

It was day-time and the weather conditions were good. Upon arrival, *Sovereign* turned around for a port side berthing at 46/47 Alto Fondale Pier (Figure 1). At 0720 (LT), she was in position with her bow about 33 m past the corner of the pier. This was her assigned berth.

During the course of the safety investigation, it was noticed that there was ample berthing space behind the vessel (Figure 4), which if used would have significantly improved the direction of the head ropes and probably altered the course of events. However, no explanation was found in the submitted evidence as to why this space was left unoccupied by *Sovereign*.
