## SIMPLIFIED SAFETY INVESTIGATION REPORT

REPORT NO.: 17/2016

### **MY *Namaste 8*** **Serious injury to passenger** **while using a powered surfboard** **03 September 2015**

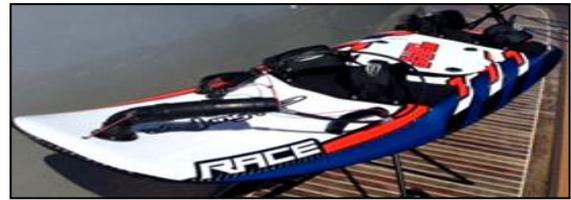
The powered surfboards were designed by race engineers (Figure 1) manufactured by JetSurf s.r.o, Brno, Czech Republic. The boards were handmade and manufactured from carbon fibre. Each had a two-stroke internal combustion engine, powering a water-jet pump for propulsion.

Figure 1: The powered surfboard available on *Namaste 8*

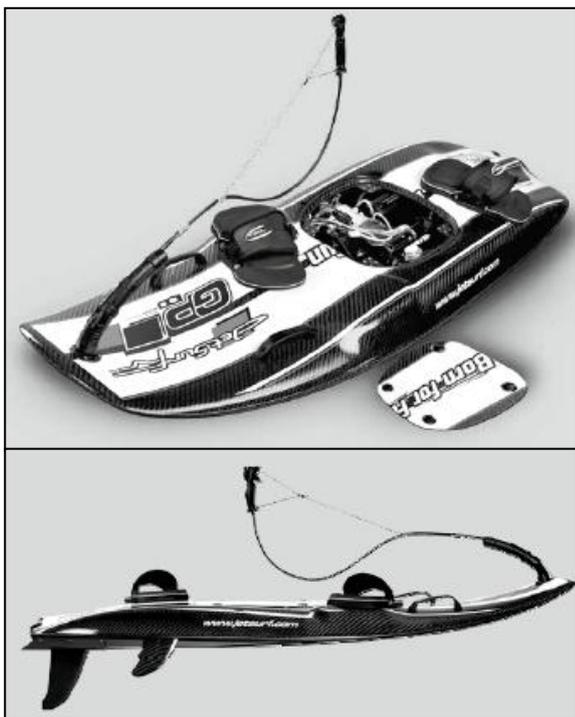
On 06 August 2015, an instructor travelled to La Ciotat, France to provide practical training and instructions to three of the yacht's crew members. For this purpose, he was using a demonstration surfboard. On 29 August 2015, two powered surfboards – JetSurf Factory GP100<sup>2</sup> were delivered in Ajaccio, Corsica (Figure 3).

Figure 3: Powered surfboard profile
