## SAFETY INVESTIGATION REPORT

REPORT NO.: 03/2020

### **MT GIOVANNI DP** **Inadvertent release of the FFLB** **and subsequent injuries to a crew member** **in position 30° 27.7' N 040° 53.6' W** **09 March 2019**

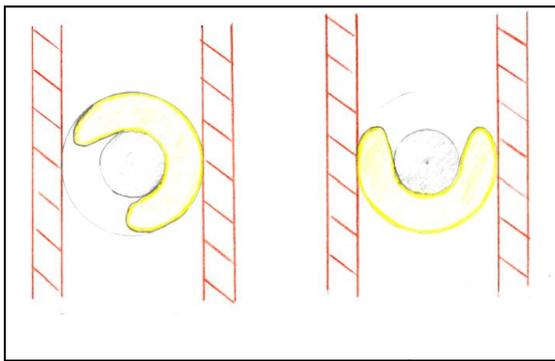
**Figure 6: Sketch showing the locker (yellow) in closed and open positions**

The Manual specified that once the mock-training was completed, the lifeboat's davit (A-frame) should be used to remove the tension from the link and to allow time to engage the hook by turning the release wheel. It further required that the locker (Figure 6) should be verified to be in the closed position when re-setting the hook. The lifeboat was then to be prepared for launching in an emergency by removing the safety bolt, detaching the lifeboat from the A-frame and removing the maintenance chain.
