## SAFETY INVESTIGATION REPORT

REPORT NO.: 19/2019

October 2019

### **MV *BALGARKA*** **Crew members' fatality and serious injuries** **during repairs in a shipyard** **28 October 2018**

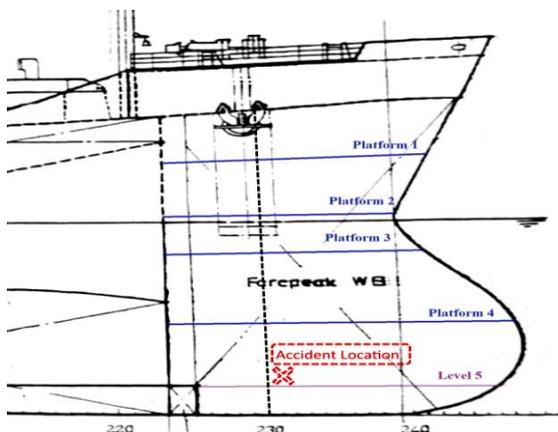
Figure 1: Forepeak tank configuration

The forepeak tank, located forward of cargo hold no. 1, extended throughout the entire height, from the main deck to the bottom shell plating. In order to provide structural strength (and facilitate access), four horizontal platforms were fitted, thereby splitting the height of the forepeak into five levels (Figure 1). Vertical ladders fitted between platforms and the bottom of the tank, provided means of access to all five levels.

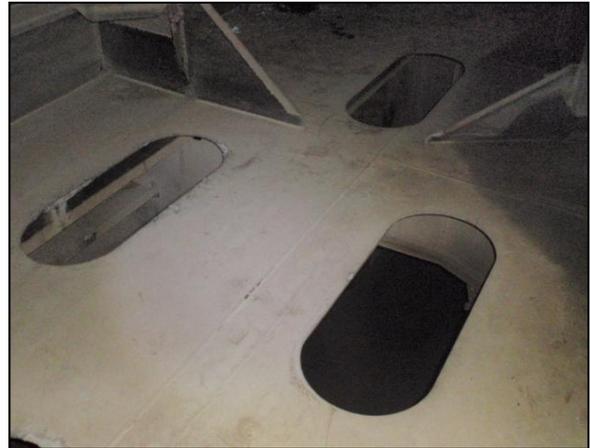
Figure 2: Configured platform nos. 1 to 4

While platform nos. 1 to 4 were fully configured platforms with access and drain openings (Figure 2), the bottom most platform no. 5 (where the accident happened) was structured differently, with deep longitudinal girders and face plates of the bottom longitudinal stringer (Figure 3).
