## SAFETY INVESTIGATION REPORT

REPORT NO.: 23/2020

### **MV LA SOLOGNAIS** **Serious injury to a crew member** **in the grey water tank** **in position 07° 43.5' N 076° 08.0' E,** **26 December 2019**

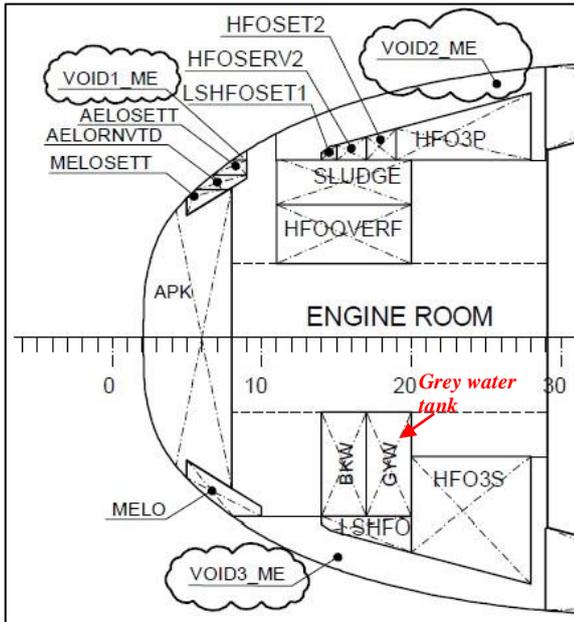
**Figure 2: Location of the grey water tank – Bird's eye view**

The grey water<sup>1</sup> tank on board *La Solognais* was fitted in the engine-room, between frame nos. 17 and 20 (Figures 2 and 3). This tank's bulkheads separated it from the main engine space, a heavy fuel oil (HFO) tank, a low-sulphur heavy fuel oil (LSHFO) tank and the black water<sup>2</sup> tank.

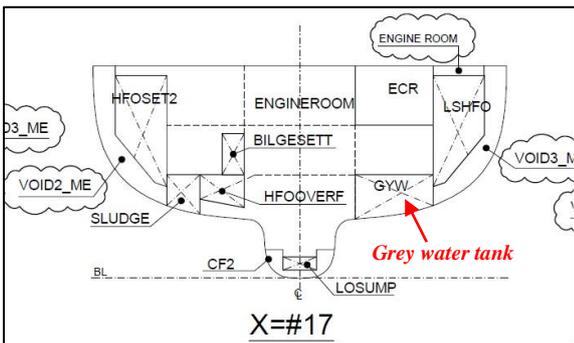
**Figure 3: Cross-section of the grey water tank, at frame no. 17 (seen from aft)**

The tank had a volume of 42.80 m<sup>3</sup>, and a maximum depth of about 3.10 m. The depth of the tank in way of its access ladder was 3.00 m. It was fitted with only one access manhole, at the top of the tank, which corresponded to the bottom platform of the engine-room. The tank's air vent opening was located on the vessel's funnel deck, at a height of 26.08 m from the top of the tank.
