SAFETY INVESTIGATION REPORT

REPORT NO.: 05/2020

MV LEOPOLD LD
Failure of auxiliary engines and the emergency generator leading to total loss of power in position 06° 08.58' N 014° 40.65' W 14 March 2019

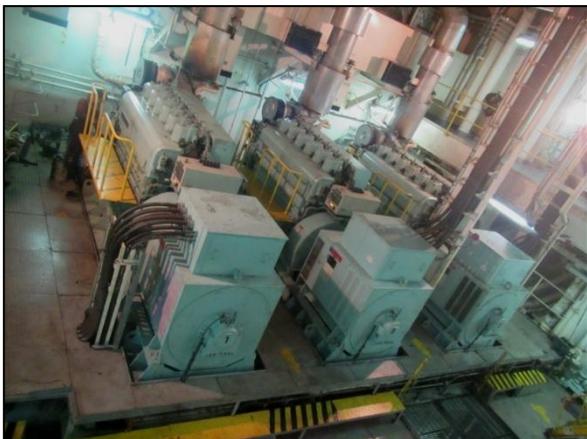
The main source of electrical power on board *Leopold LD* were three Yanmar 6EY22ALW auxiliary diesel engines (Figure 1), each capable of bearing the full electrical load of the vessel, under normal operational conditions. The rated output power of each of these auxiliary engines was 970 kW.

Figure 1: Auxiliary engines on board *Leopold LD*

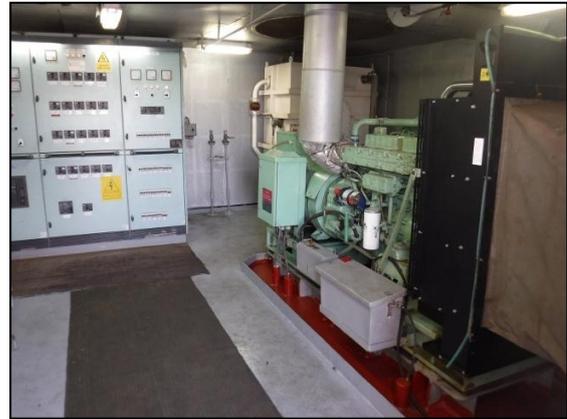
The emergency source of electrical power was a Sisu 645 DSBIG diesel generator, which had a rated output power of 170 kW (Figure 2).

Figure 2: Emergency generator of *Leopold LD*

At 0310, after running for a period of 12 hours, two fan belts on the emergency generator broke. These were replaced by new ones; however, 30 minutes later, the radiator of the emergency generator started to leak and consequently, the generator had to

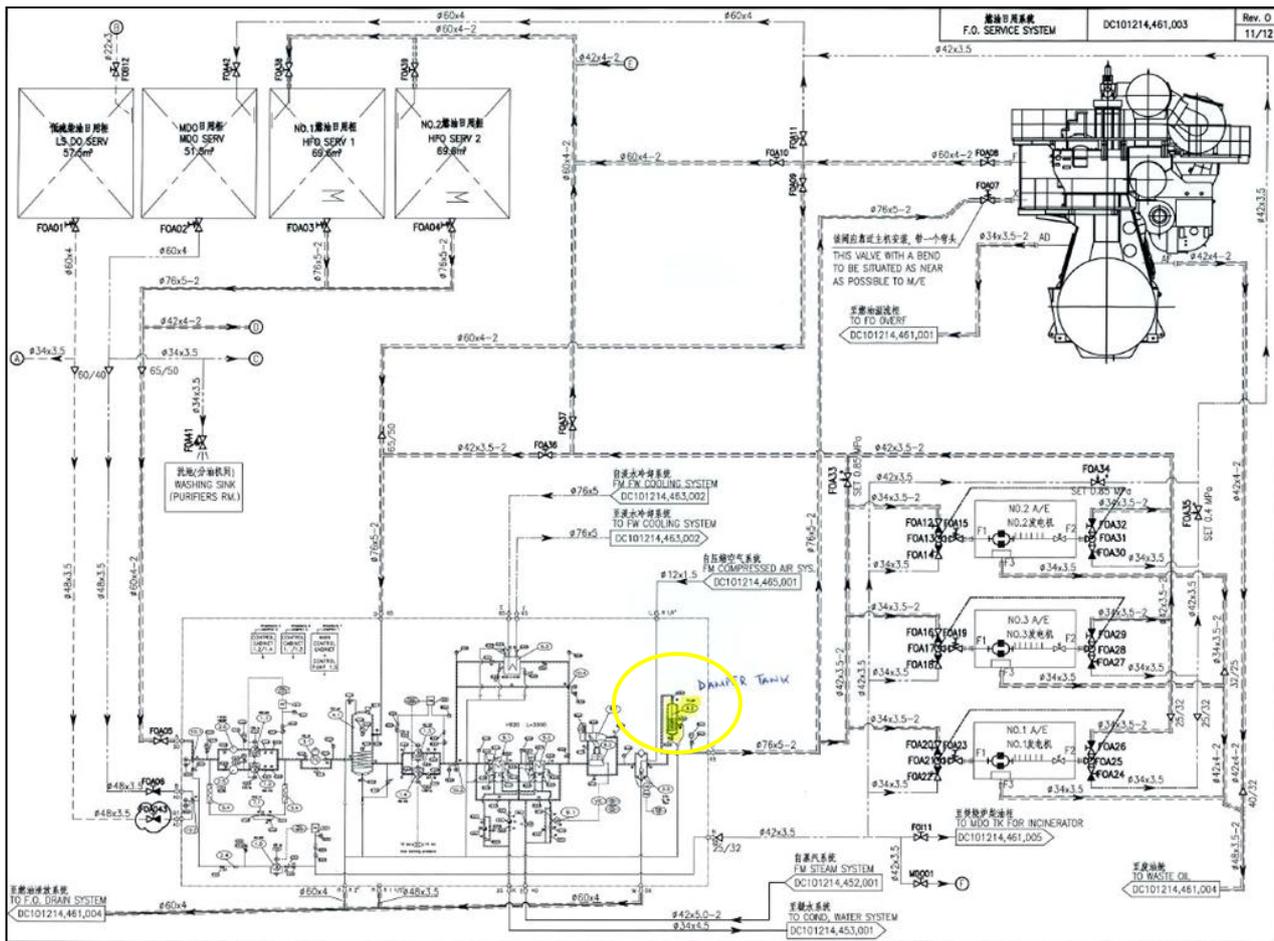
It was also found that the fuel compensation damping tank was empty and that the drain valves of the diesel oil service tanks were blanked.

The tank (Figure 7) had a nominal capacity of approximately 19 litres with a maximum working pressure of 1.6 MPa⁴.

As per the manufacturers' instructions, this tank had to be kept pressurized with an air cushion charge. In addition to the damping of pressure, the manufacturers' instructions also stated that if this tank was properly operated and kept correctly charged, the fuel oil pressure in the supply lines would be sufficient, for a few minutes, to start the auxiliary engines without having to put the fuel oil supply and booster pump in service; *i.e.* even during a black-out, sufficient pressure would be maintained in the fuel supply lines to the engines.

Figure 7: Fuel oil service system, showing the damper tank in yellow

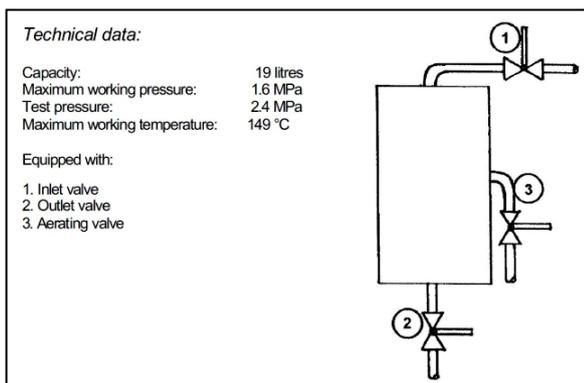
The tank was fitted with a fuel inlet valve, a fuel outlet valve and an aerating valve, as shown in Figure 8.

Figure 8: Side elevation of the compensation damping tank
