SAFETY INVESTIGATION REPORT

REPORT NO.: 12/2018

MV MSC RAVENNA **Fatal fall overboard of a crew member** **in the port of M'Xlokk** **22 June 2017**

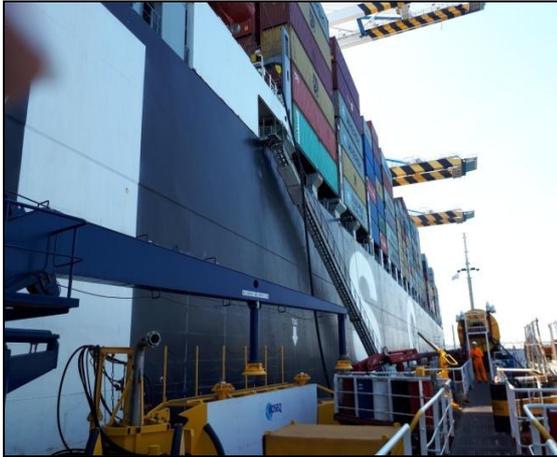
Figure 2: MSC Ravenna and Balluta Bay alongside

During her cargo discharge operation, the vessel was to bunker 700 metric tonnes of high sulphur fuel oil. A local bunker barge, *Balluta Bay*, arrived alongside *MSC Ravenna* at 2030 and moored with her port side alongside the container vessel's port side (Figures 2 and 3).

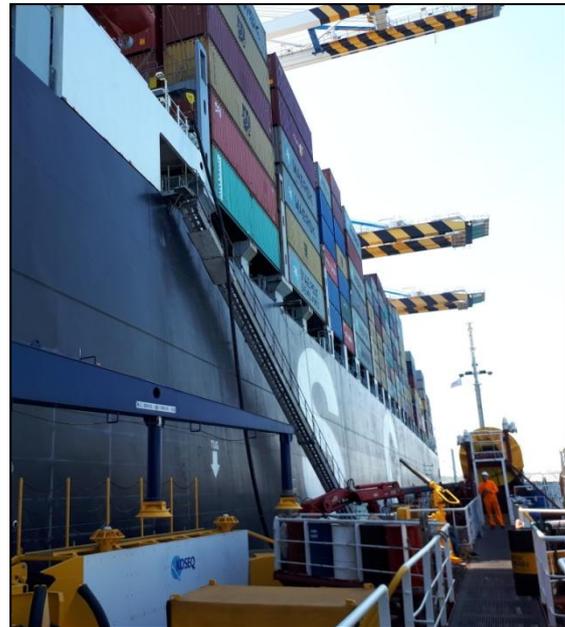
Figure 8: Accommodation ladder to the bunker barge

At the time of the accident, the master / chief officer and the AB1 were on the catwalk a few metres aft of the bunker barge cargo manifold. The swinging bunker hose attracted their attention. However, the master / chief officer also observed a person falling over the shipside and hitting the accommodation ladder's railing.

The port side accommodation ladder of *MSC Ravenna* was lowered between both

vessels' port sides, onto the *Balluta Bay* in order that *MSC Ravenna*'s engineers could access the bunker barge and control the tanks' soundings (Figure 8).
