## SAFETY INVESTIGATION REPORT

REPORT NO.: 02/2019

### ***MV NEW HAMPSHIRE TRADER*** **Boiler furnace blowback and injuries to two crew members about 30 nautical miles from Qingdao Pilot Station 31 January 2018**

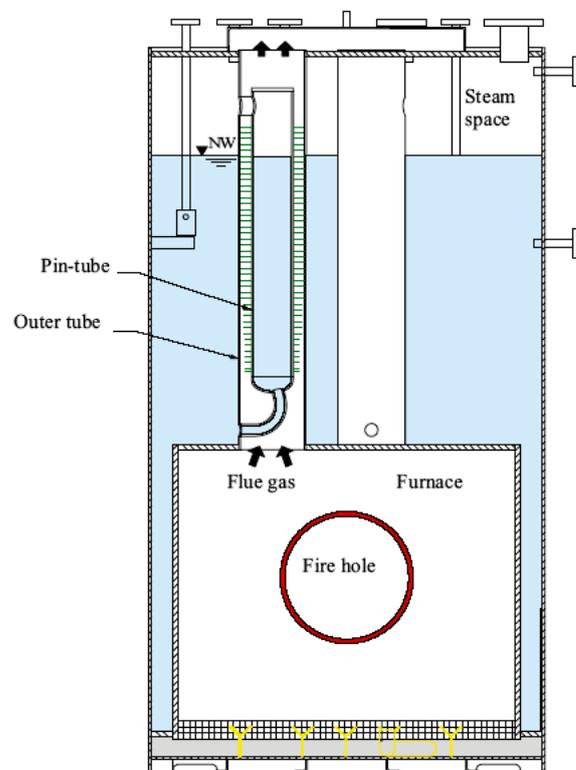
Figure 1: Auxiliary boiler arrangement

The auxiliary boiler in question, constructed by Alfa Laval, was oil-fired. The mountings were mainly mounted on the top of the boiler body, allowing for a simple connection to the piping systems on board the ship. The control system provided for a fully automated operation of the boiler and the burner. As shown in Figure 1, the boiler was of a vertical cylindrical design with a shell surrounding a cylindrical furnace, and a convective section consisting of pin tube elements. The maximum design pressure was 9 bars, with a maximum continuous steam capacity of 2700 kg $hr^{-1}$ .
