# SAFETY INVESTIGATION REPORT

REPORT NO.: 08/2018

## **MV POMPANO** **Fall from a height into a cargo hold** **resulting in fatal injuries to one crew member** **in Port Hedland Anchorage, Australia** **08 April 2017**

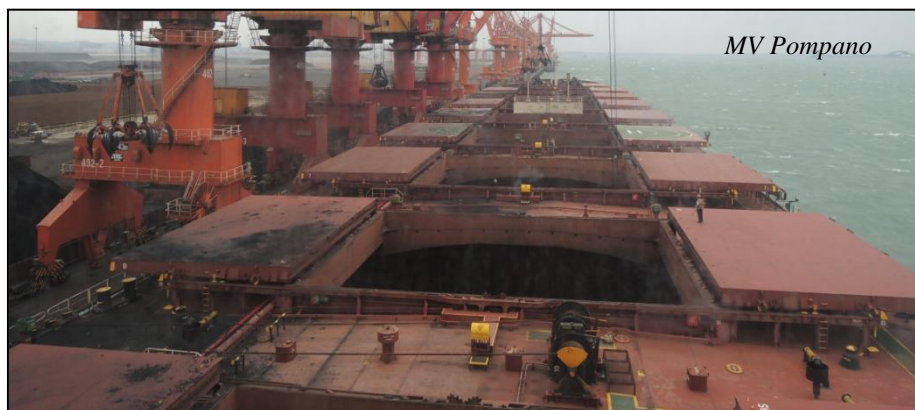
The third engineer was wearing a safety belt and a safety helmet, in addition to welding PPE. The repairs had to be carried out in way of the lower platform, which was about 5.9 m above the tank top (Figure 1).
