SAFETY INVESTIGATION REPORT

REPORT NO.: 18/2021

MV RIMONA **Fatal injury to a crew member** **during cargo loading operations,** **on the pier at the port of Habas, Turkey** **09 September 2020**

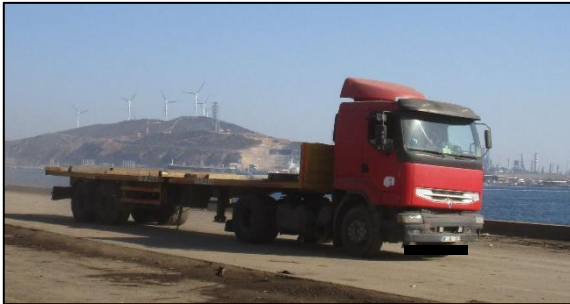
The cargo of steel rebars bundles, was being brought alongside the vessel on open trailer trucks (Figure 1). The bundles were then lifted from the trucks by a shore crane and loaded on board the vessel (Figure 2).

Figure 1: An open trailer truck, identical to the ones on which the cargo was brought alongside *Rimona*

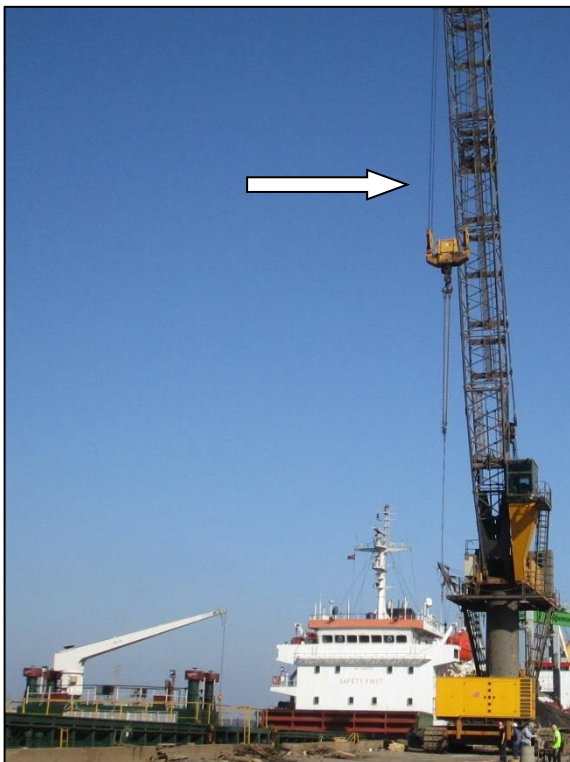
Figure 2: The shore crane used for cargo loading
