SAFETY INVESTIGATION REPORT

REPORT NO.: 07/2017

MV Azamara Quest **Fire in the engine-room** **In position 19° 51.7' N 068° 31.8' E** **27 April 2016**

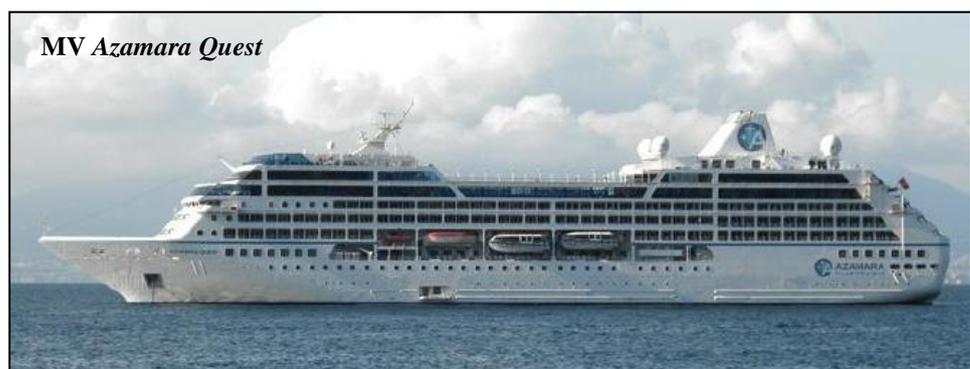
The staff chef engineer hurried towards the diesel generator room and from the inside, he observed a dark orange fire under the turbocharger of diesel generator no. 2, on the B-bank side.

The fire was brought under control within a few minutes, limiting the damage to the immediate surroundings of the turbocharger.

The immediate cause of the fire was identified to be a pressurised fuel oil leak from a loose fuel oil pipe flange.
