SAFETY INVESTIGATION REPORT

REPORT NO.: 08/2017

MV SEAGULL **Fatal fall overboard** **in Trincomalee, Sri Lanka** **28 April 2016**

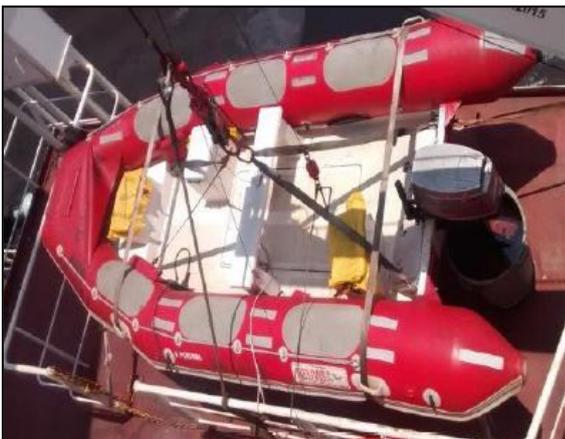
Figure 4: The ship's rescue boat

The deck boy observed the chief mate grasping the lifebuoy (without line), which he had just tossed, after which, he rushed to the ship's office to raise the man overboard alarm. On his return to the poop deck, he saw the chief mate flaccid and not moving. He jumped into the sea with two able seamen to keep his face out of the water. Meanwhile, a rescue boat (Figure 4) was launched and the ship's agent and port authorities were informed of the occurrence by VHF radio.

Shortly afterwards, the chief mate was recovered and administered CPR in the rescue boat and on board the vessel. A naval patrol boat, which was alerted of the medical emergency on *Seagull*, took the chief mate on board and transported him ashore for further medical treatment. However, upon arrival at the hospital, the attending doctor examining the chief mate and pronounced him dead.
